UNITED STATES AIR FORCE
AIRCRAFT ACCIDENT INVESTIGATION
BOARD REPORT

MH-53M, S/N 73-1648

**16th Special Operations Wing
20th Special Operations Squadron
Hurlburt Field, Florida**

SUMMARY OF FACTS AND STATEMENT OF OPINION
MH-53M, S/N 73-1648
22 MAY 2003

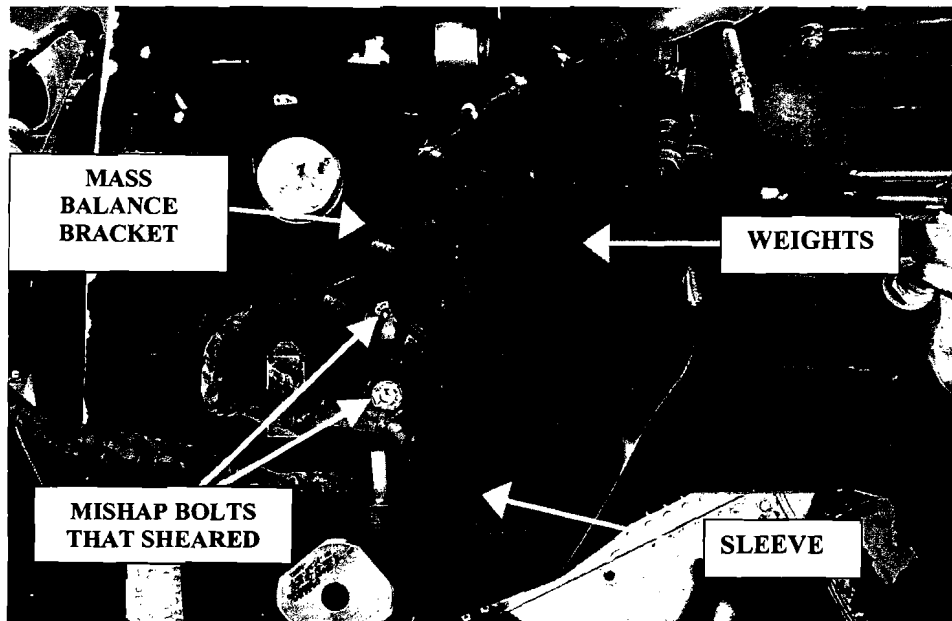
Mass Balance Bracket and Weights
